Vessel Survey Report No. 2438

Date of Survey: 23 December 2011

Vessel surveyed: 'FIREFIGHTER' City of Boston Fireboat

Purpose of survey: Condition and valuation

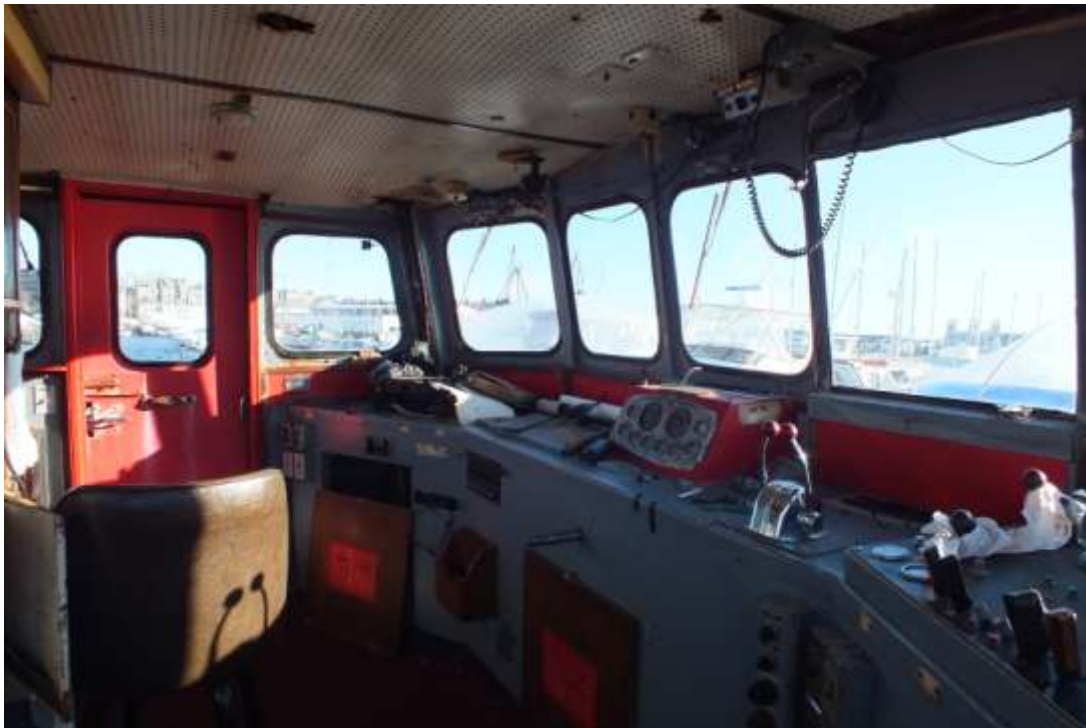
Her interior accommodations include on maindeck from forward a wheelhouse with storage flat beneath, followed down and aft by the crew messdeck with an L-shaped galley to port, serving table to port and a storage locker to starboard. The wheelhouse has been stripped of all navigation electronics and paperwork; the chart table has had its cover table ripped out. MORSE dual main engine controls are fitted with a DETOIT DIESEL main engine gauge panel showing 5,665.1 port and 4,062.1 hours on the meters; no engine machinery logs are aboard and the main engine histories are missing. The steel surrounding all of the wheelhouse windows is badly corroded with leakage noted. The overhead has a fiberboard with insulation fitted; this has been pulled away on the portside adjacent to the windshield exposing wiring. The cabin sole has deteriorated carpeting installed. A pair of exterior doors are fitted with exterior portable stairways provided; the frames and door handles are corroded.

Wheelhouse, looking to port.

- 1.) **Have extinguishers inspected and tagged (annually).**
 - 2.) **Clean bilges of standing oil from all portions of bilge spaces.**
 - 3.) **Properly winterize vessel's propulsion, generator and auxiliary systems.**
 - 4.) **Install proper electronic navigation equipment.**
 - 5.) **Install approved safety gear.**
 - 6.) **Properly assess condition of main propulsion and generator machinery.**
-

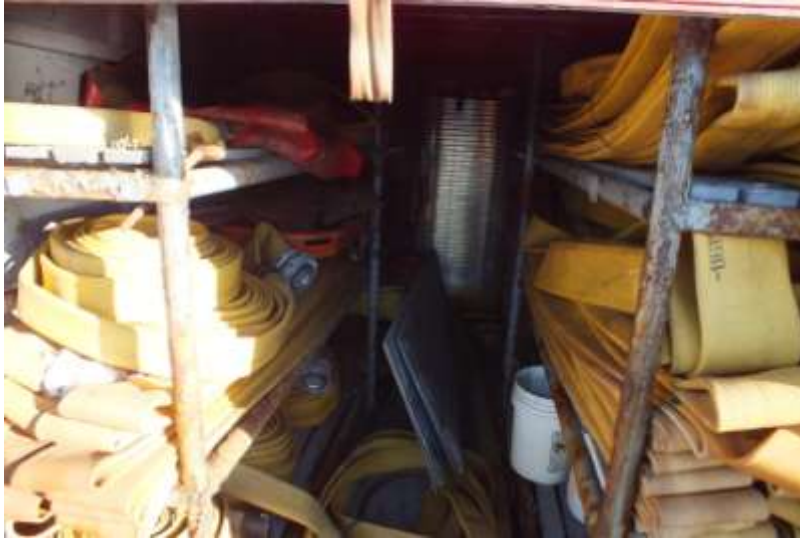
An exterior door is fitted for access to the Engineerroom. A storage bay is fitted aft with accordion door and has steel pipe storage shelves for hoses and miscellaneous equipment. The pipe racks are badly corroded. A wooden storage rack is fitted to the aft deck for hand tools.

Aft storage locker.

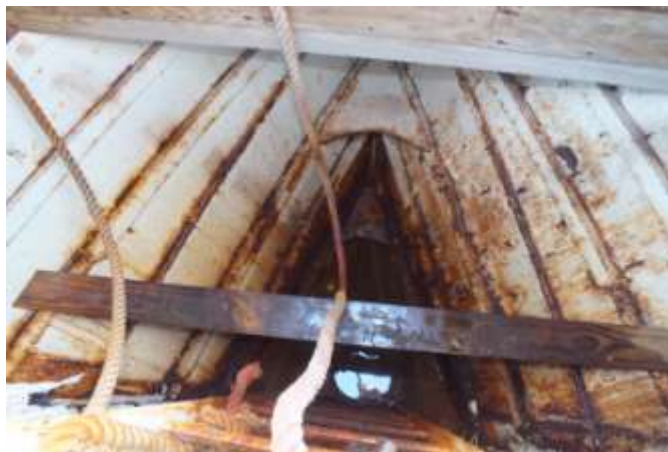
Accessed from maindeck via a watertight dogging hatch; the forepeak tank show much evidence of rust/scale with 1 ½' of standing water. Paint system has failed and there is much degradation of steel scantlings present.

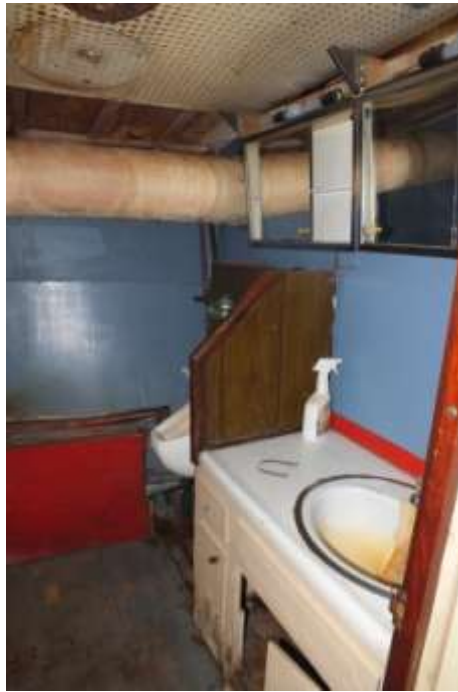
The head has a sink, enclosed shower stall, toilet and urinal installed; all plumbing is suspect, has not been winterized and is in poor material condition. The space itself has lifting tile, poor

cabinetry and the overhead panel has been pulled down in places.

View of head from passageway.

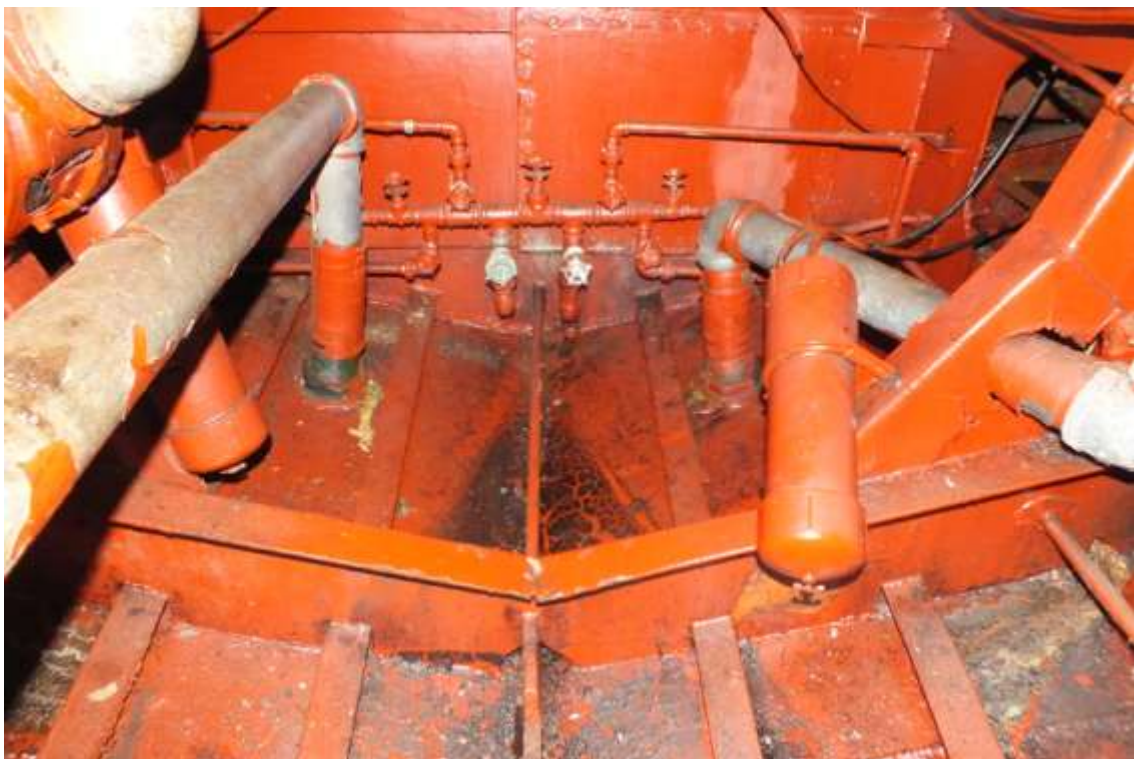
Located amidships between two watertight dogging doors, the Engineroom comprise the pair of main propulsion units and running gear, two firemain pumps and main engines and a pair of diesel generators. The cabin sole has removable steel floor insets. Bilges have standing oil/water, but not to an alarming degree. Structural integrity is intact with good foundations, bulkheads and frames noted.

Bilges, amidships, Engineroom.

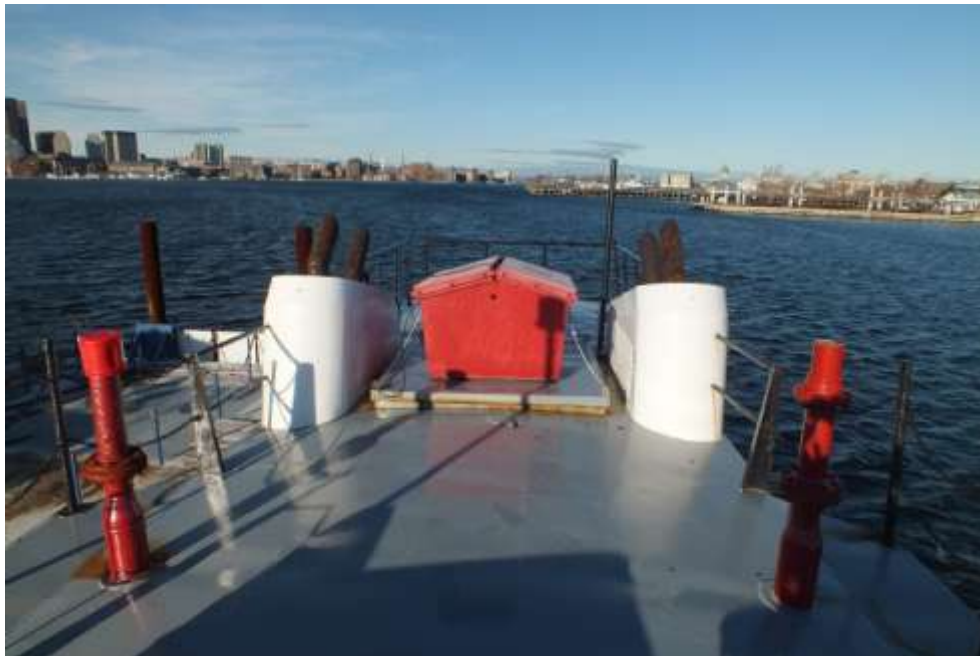
All electronic gear has been removed. Surface corrosion noted around windows. Heavy corrosion on stacks. A wooden box amidships contains many Type I PFDs in various conditions. Two steel access ladders from maindeck; steel railings in good condition.

Upper deck, looking aft. Notice cut off fire main risers.

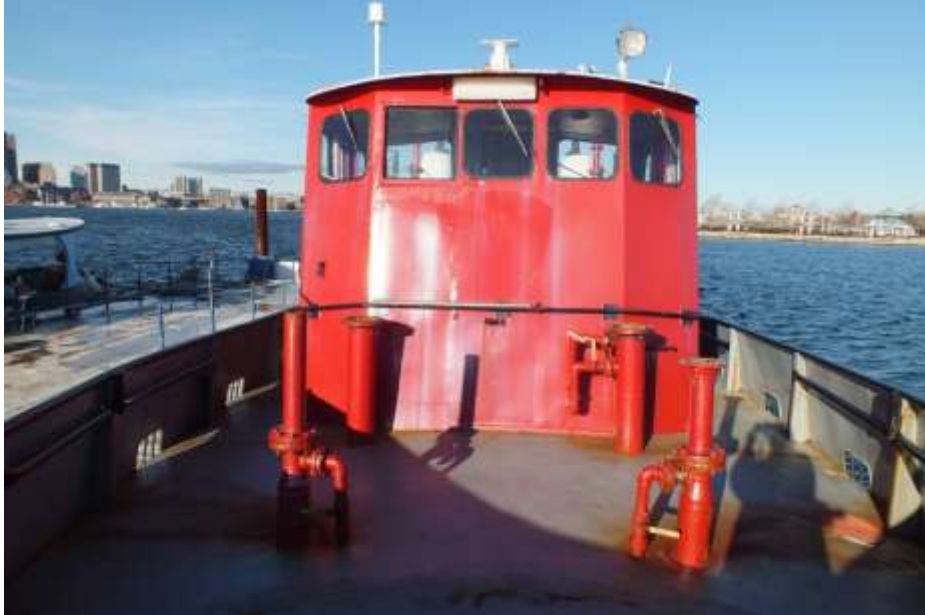
All fire monitors and safety gear has been removed.

Foredeck, looking aft. Notice steel risers where fire monitors have been removed.

This craft is in good material and poor cosmetic condition. Her future utilization as a fireboat is a possibility provided the hull is hauled for inspection and her fire monitors are reinstalled. The vessel's electronic navigation systems also require update. The vessel needs to be hauled and bottom cleaned with new anti-fouling paint installed. The boat should be vacated of all linens, and moisture bearing clothing, upholstery, carpeting and old material and be cleaned top-to-bottom.

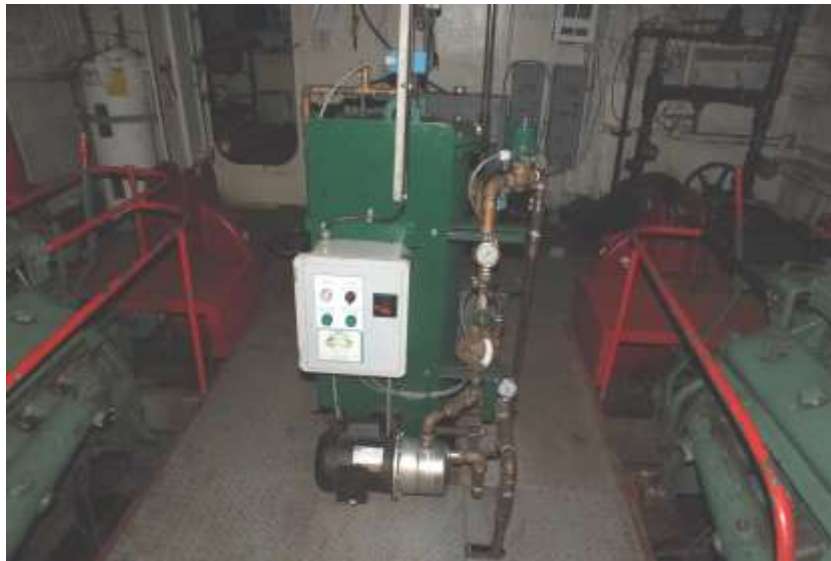
A BOSS (bilge oil strainer system) is fitted on the centerline between both fire pumps; this system needs to be drained and winterized.

BOSS system in Engineerroom.
