Vessel Survey Report No. 2438

Date of Survey: 23 December 2011

Vessel surveyed: 'FIREFIGHTER' City of Boston Fireboat

Purpose of survey: Condition and valuation

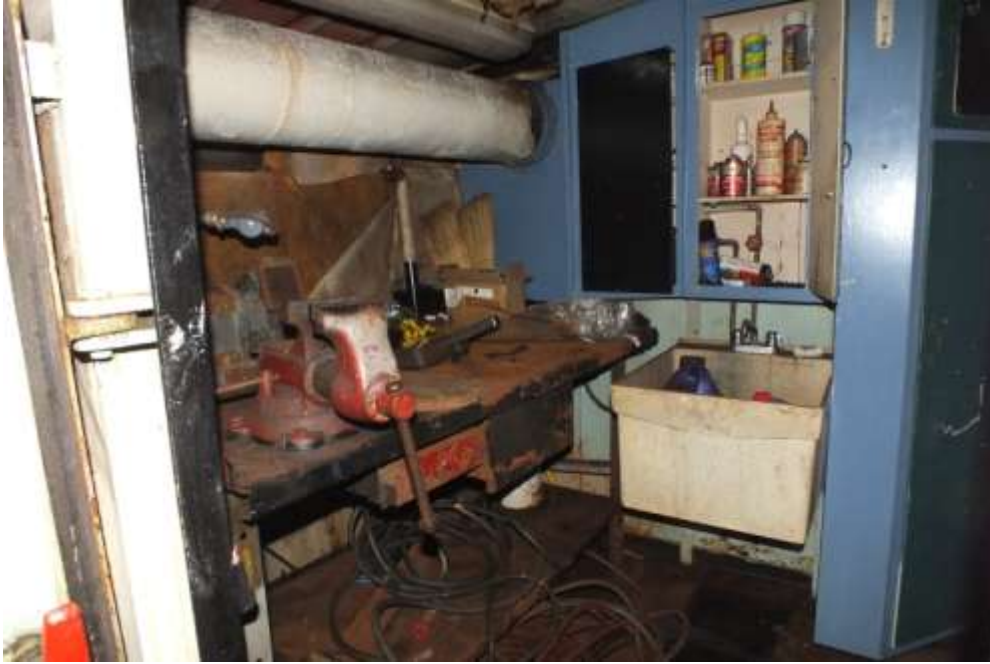
Workshop.

The workshop/storeroom to port has a work bench with vise and lockers filled with spare parts. Ample extra fuel/oil filters are supplied. Most tools have been removed. Space is in fair material condition.

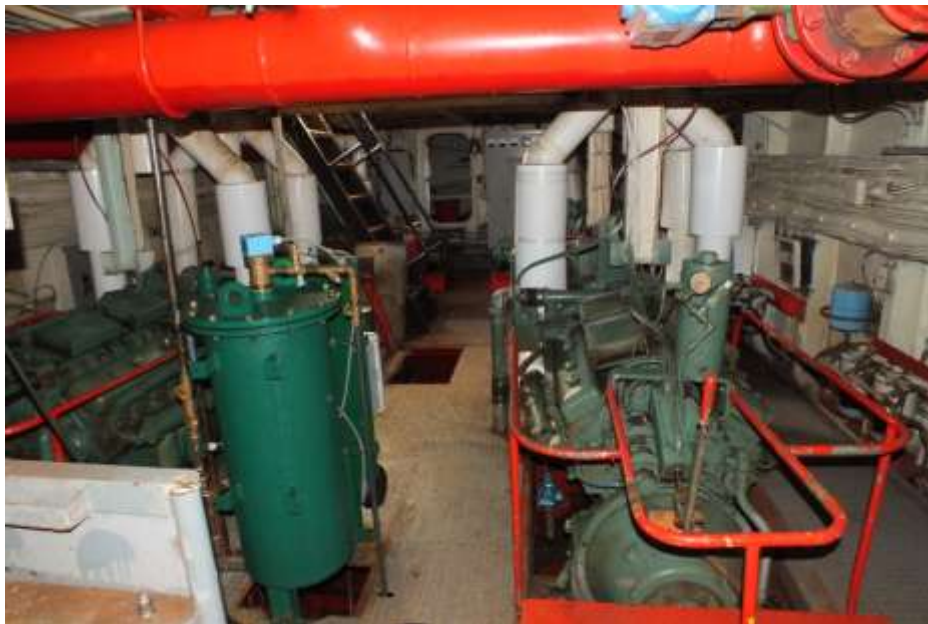
Engineroom, looking aft.

Located amidships between two watertight dogging doors, the Engineroom comprise the pair of main propulsion units and running gear, two firemain pumps and main engines and a pair of diesel generators. The cabin sole has removable steel floor insets. Bilges have standing oil/water, but not to an alarming degree. Structural integrity is intact with good foundations, bulkheads and frames noted.

- 1.) **Have extinguishers inspected and tagged (annually).**
 - 2.) **Clean bilges of standing oil from all portions of bilge spaces.**
 - 3.) **Properly winterize vessel's propulsion, generator and auxiliary systems.**
 - 4.) **Install proper electronic navigation equipment.**
 - 5.) **Install approved safety gear.**
 - 6.) **Properly assess condition of main propulsion and generator machinery.**
-

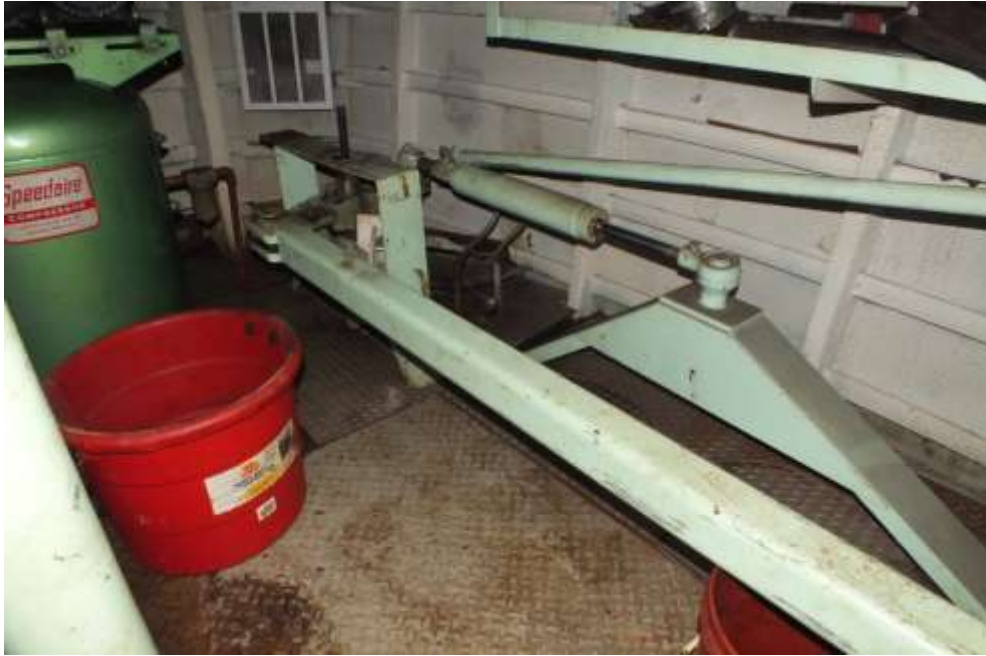
This space is aft of the Engineeroom and comprises the following: steering gear, two air compressors, lube oil tank and fuel transfer assembly/hose. The cabin sole has removable steel floor insets. Bilges have standing oil/water, but not to an alarming degree. Structural integrity is intact with good foundations, bulkheads and frames noted.

Starboard side of lazarette, showing starboard rudder post and steering gear assembly.

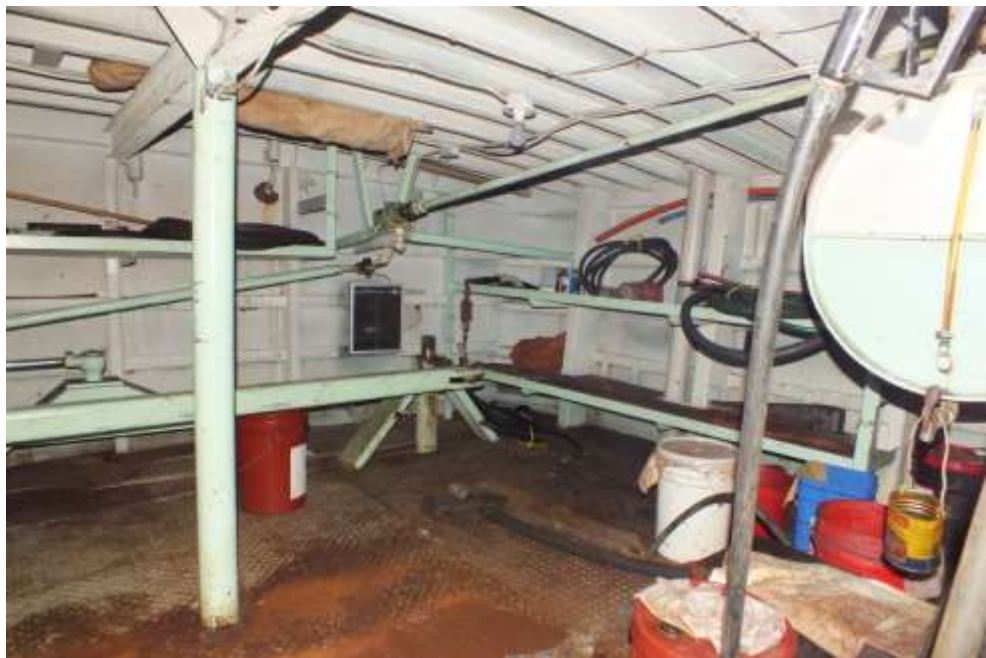
Port side of lazarette, showing lube oil tank and port steering/rudder post assembly.

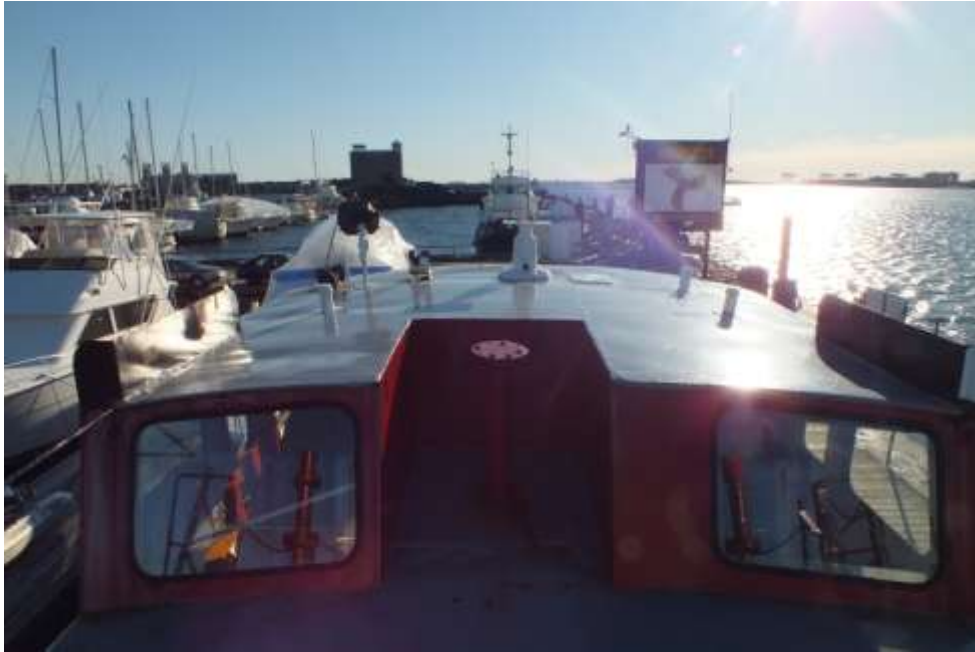
Upper deck, looking forward.

All electronic gear has been removed. Surface corrosion noted around windows. Heavy corrosion on stacks. A wooden box amidships contains many Type I PFDs in various conditions. Two steel access ladders from maindeck; steel railings in good condition.

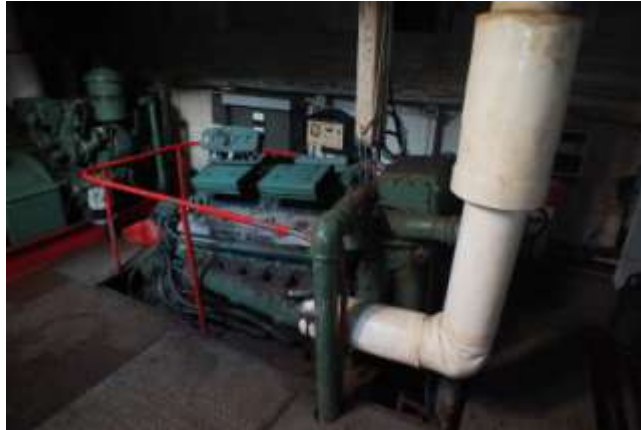
Port main propulsion unit.

The vessel is equipped with a pair of DETROIT DIESEL 12V-71, two cycle, V-12 diesel engines powering a pair of TWIN DISC (model MG-514) hydraulic gears thence to 3" stainless steel shafts. The shafts pass through a pair of bronze flax packing glands (not leaking at time of inspection); the underwater appendage was not observed. Both main engines are air started. Both engines are fresh water cooled though keel coolers. Exhaust is vented (dry) via lagged steel piping for discharge at the stacks. Main engines and gears were not operated at time of inspection. Engine hours and histories unknown.

The true condition of the propulsion and generator machinery should be assessed.

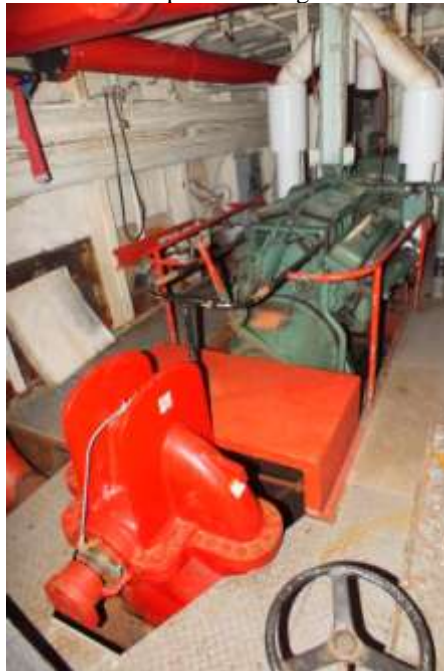
Port main drive engine, PTO and fire pump.

The vessel is equipped with a pair of DETROIT DIESEL 12V-71, two cycle, V-12 diesel engines powering a pair of TWIN DISC manual gears thence to a power take-off (PTO) for the pair of fire pumps. Nomenclature of the pumps is not known as all paperwork is missing from vessel. Both main engines are air started. Both engines are fresh water cooled though keel coolers. Exhaust is vented (dry) via lagged steel piping for discharge at the stacks. Main engines, gears and pumps were not operated at time of inspection. Engine hours and histories unknown.

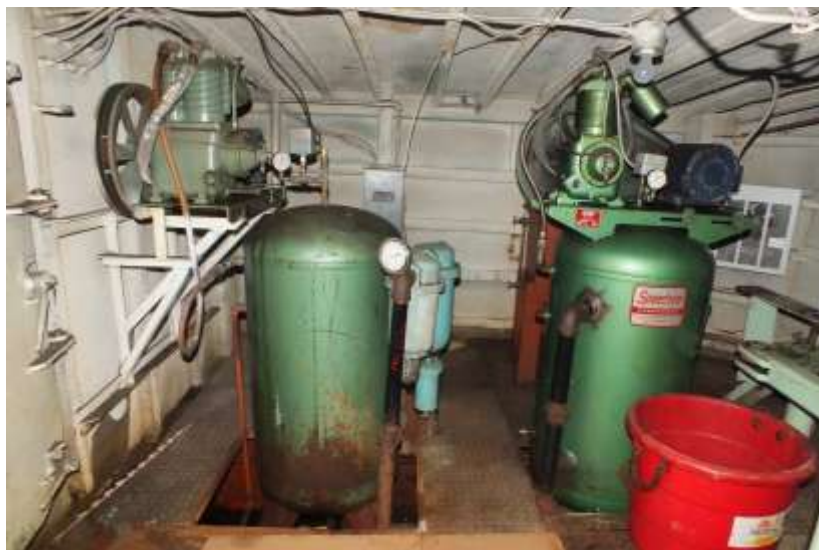
Two SPEEDAIRE compressors (model 12733) are fitted in the lazarette and appear to be in good repair.

Pair of SPEEDAIRE compressors and storage tanks in lazarette.

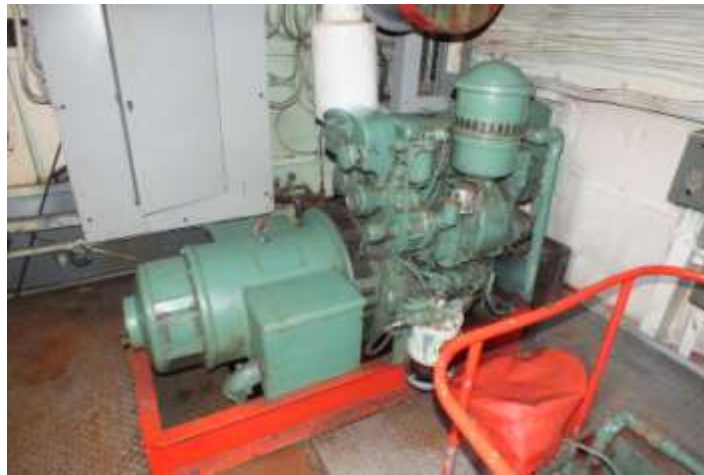
Port main generator.

A pair of DETROIT DIESEL two stroke 3-71 diesel engines drive a pair of DELCO 50 KW generators; both diesels are fresh water cooled via keel coolers. Exhaust is vented (dry) to the stacks. DAHL fuel/water separators are fitted. Both generators have a pair of 8D batteries with battery switch for engine starting; a converter is fitted for charging both battery banks.
